PRECAUTIONARY INSPECTION OF SR 3000/3N PROPELLERS

SR 3000/3WN Propeller
Three-bladed, in flight adjustable

SERVICE BULLETIN
No. UL 01/2017, Rev. 01

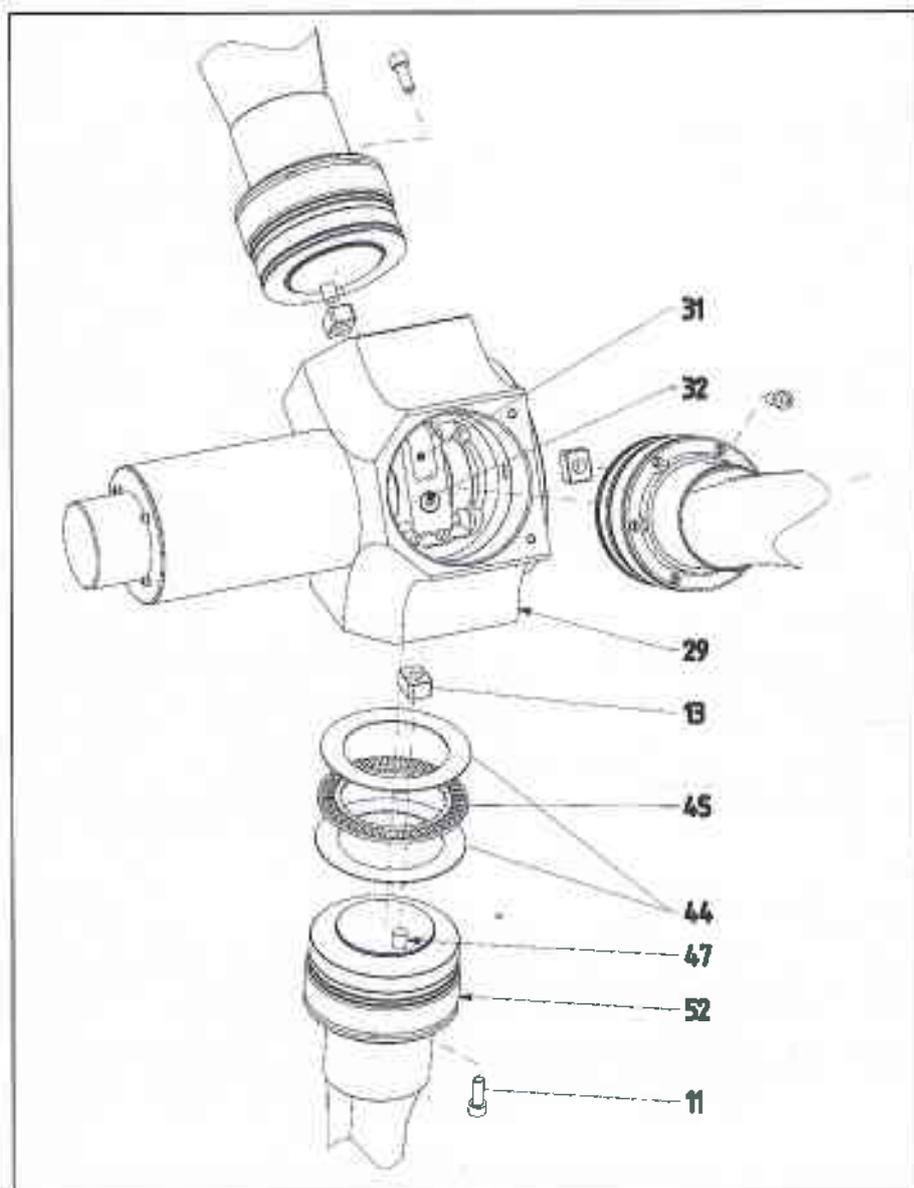
Propeller blades removal

1. Remove securing wire from three pairs of Allen head screws **pos. 11** on propeller blade retention nut. Use 5mm Allen key to gradually loosen the screws, and remove them.

2. Loosen retention nut **pos. 52** using wrench P-303 and use your hand to unscrew retention nut from propeller hub. Pull propeller blade from propeller hub. If blade does not leave the hub, it sticks to walls of the hole by grease layer. Try to rotate the blade and pull it at the same time.

3. Remove axial bearing **pos.44, 45**, and slider **pos.13** from the space where propeller blade was, unless the parts were stuck to propeller blade by grease layer and have not been removed along with blades. Use grease to stick the parts onto ferrule of removed propeller blade.

4. Put protective pouch onto removed blade and secure it by tape to ensure that bearings and sliders cannot get lost.
5. Remove propeller blades 2 and 3 in the same way.
